Historic New Market, Maryland

1969 Survey

( This group of houses situated

( on NORTH SIDE OF MAIN STREET

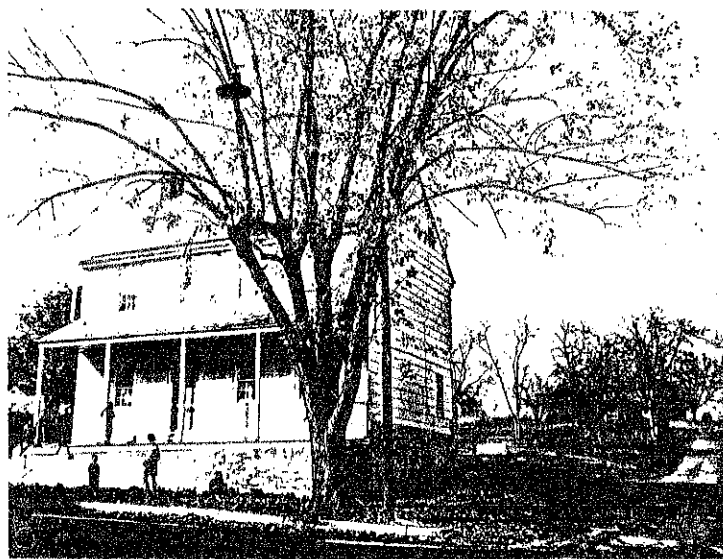
1.  
Federal & Main St.  
North Side

Owner -  
Charles A. Jackson  
One-family dwelling

Original owner - George Smith  
House used as an early inn  
Weatherboard  
Circa 1800

Post-Colonial

Good style  
No or little disecration  
Good physical condition

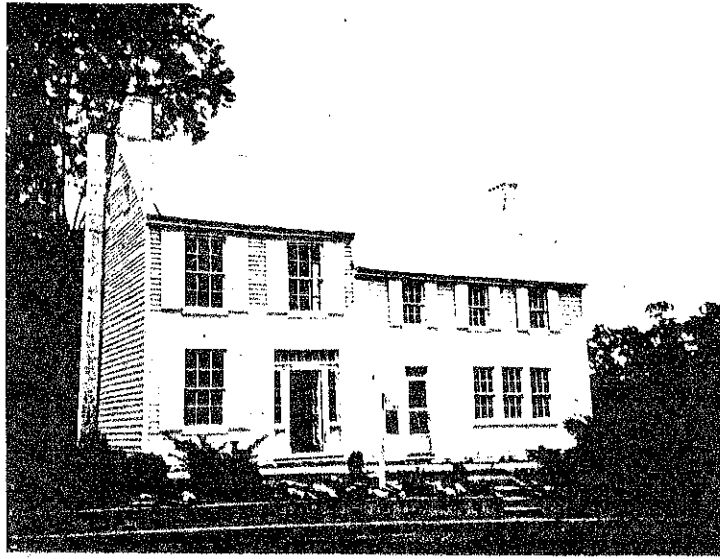
Present Owner - Mrs. Catherine Miller  
One Family

Federal - 1800-1830  
Fair Style  
Considerable Change  
Good condition

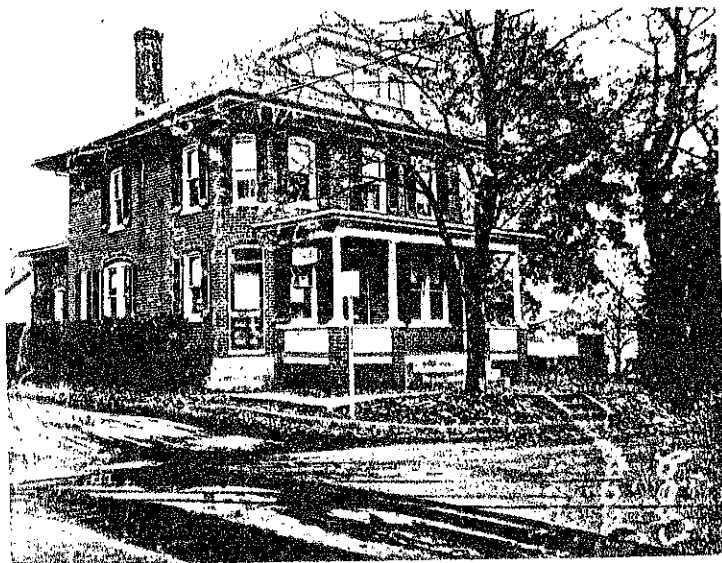
Prospect Alley & Main  
East Side

Owner - Jane Downey  
 Original Use - Dwelling & Store  
 Presently one family-dwelling

Federal - 1825

Good style

No or little change

Good condition

Jesse Wright built & operated the store fronting Main Street circa 1825. Back of building built much earlier.

Front of dwelling operated as a button factory before the store was built. Legend has it that the Angamone Mounted Rifles, disbanded at the start of the Civil War, cached their weapons in the outhouses on the property, where they were confiscated & discovered by the Union soldiers.

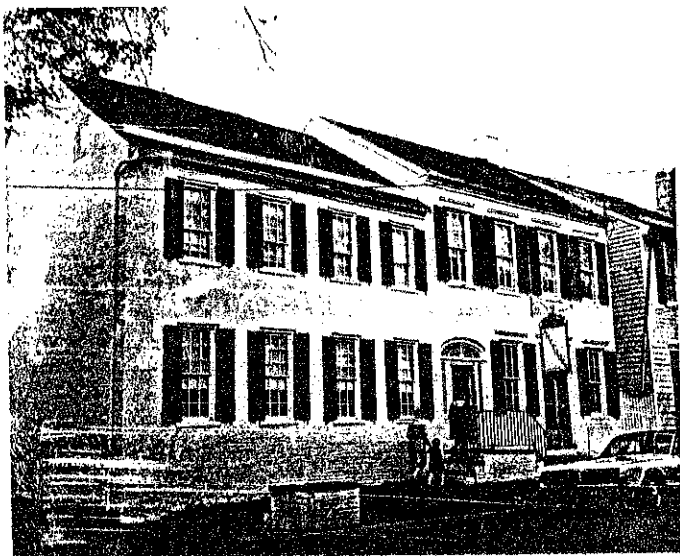
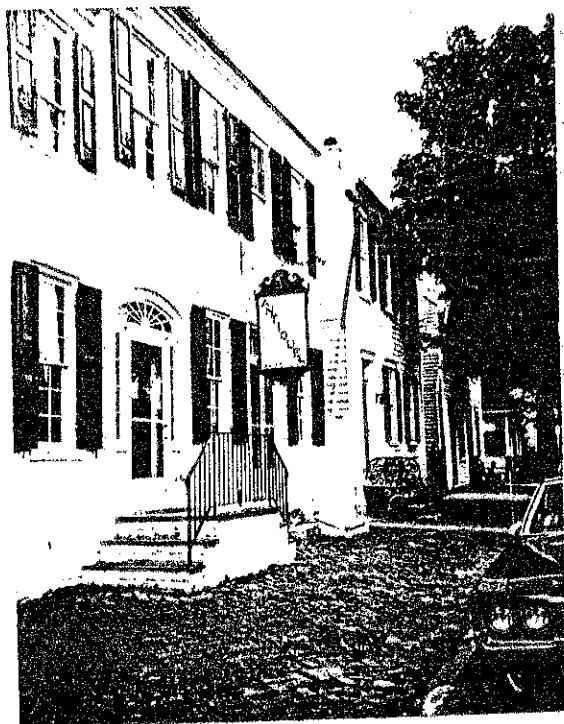
4

Owner - Franklin Rappold  
Original Use - Dwelling &  
Post Office in 1798.

Present Use - One family  
Commercial

Federal 1800 - 1830

Good style

Moderate amt. of change

Good condition

This property had many  
uses, among them, as  
a tavern and as  
early as 1840 a  
full blown Hotel,  
the National Hotel.

1. Elliptical fan door with side windows also

2. Wrought iron railings.

3. Two interior end chimneys

4. Over windows - end blocks with center block -  
triangular section over windows on lower floor

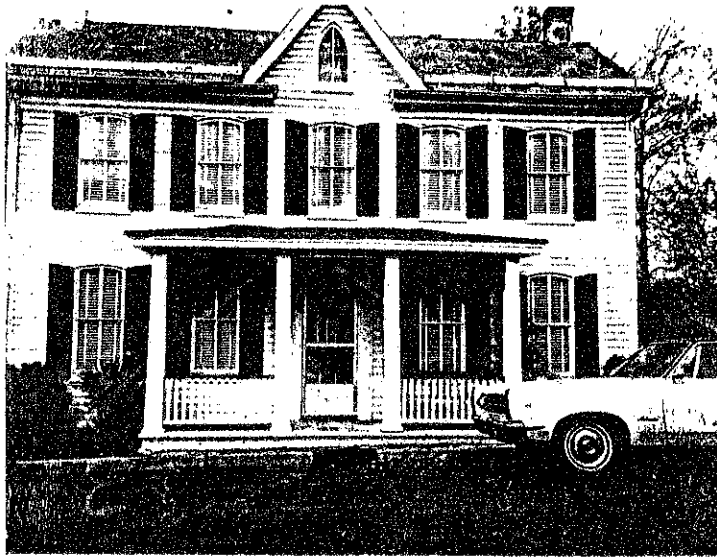
7.

Owner -

W. Franklin Smith

One family

Weatherboard

Victorian 1835-190

Good style

NB or little change

Good condition

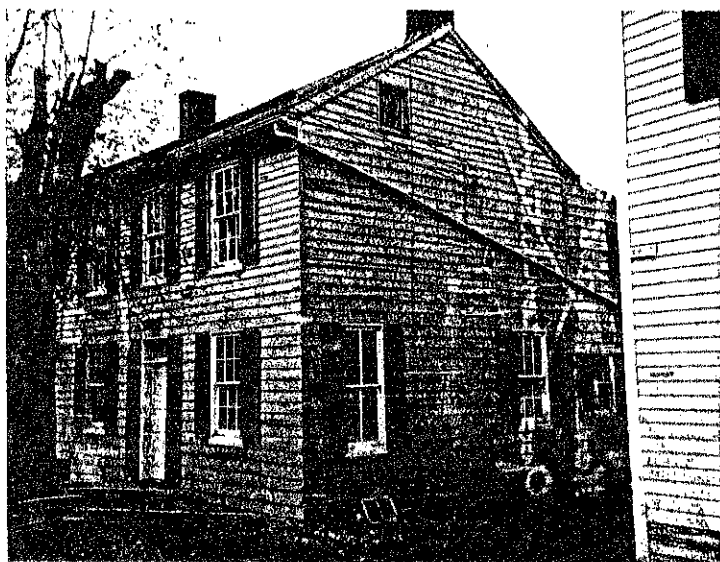
8.

Owner - Ray Massanelle  
Original Use - Dwelling  
Present Use - Dwelling -  
One family & Commercial

Weatherboard

Federal 1800-1830

Good style

Considerable change

Excellent condition

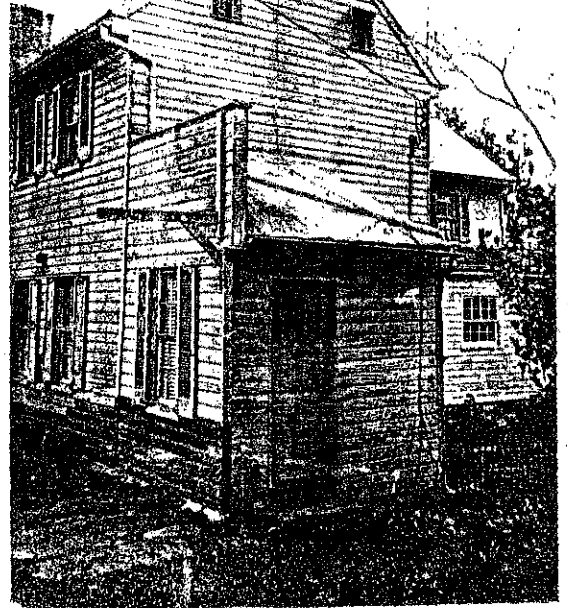
Owner - Mr. & Mrs. Morse Prosser

Stone, brick & weatherboard

Year Built - 1803

Federal 1800-1830

Excellent style

Moderate amt of change

Good condition

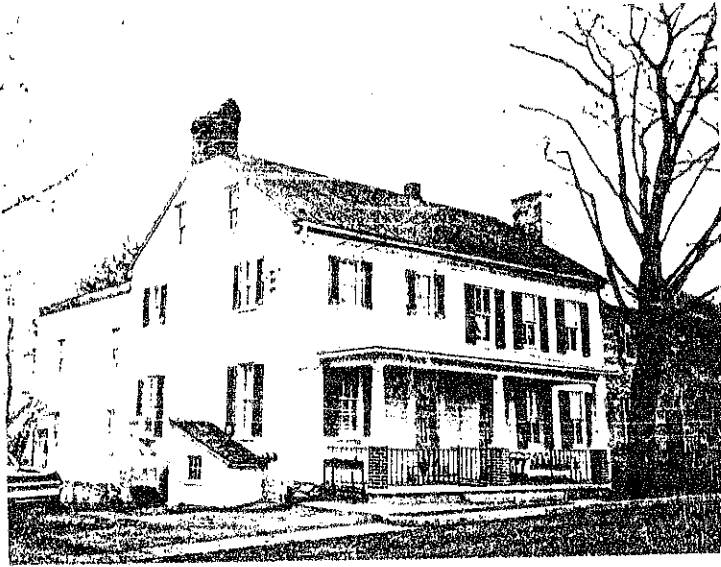
Owner - Mr. & Mrs. Arthur Esworthy  
 Brick and Weatherboard  
 Two Family - Present

Brick 1798 -  
 Weatherboard - 1890

Post-Colonial - Victorian  
 Good Style  
 Moderate Amt. of Change  
 Excellent Condition

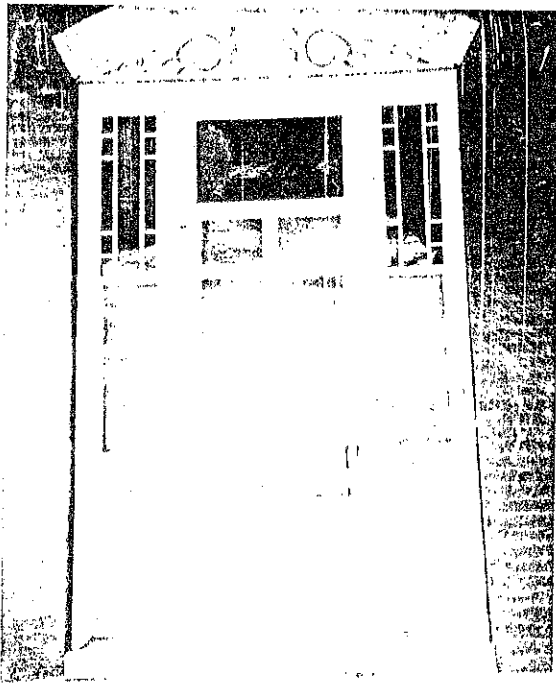
Owner - Mr. Jesse Burrall

Brick - 1880

Victorian

Exceptional style

No or little change

Good condition

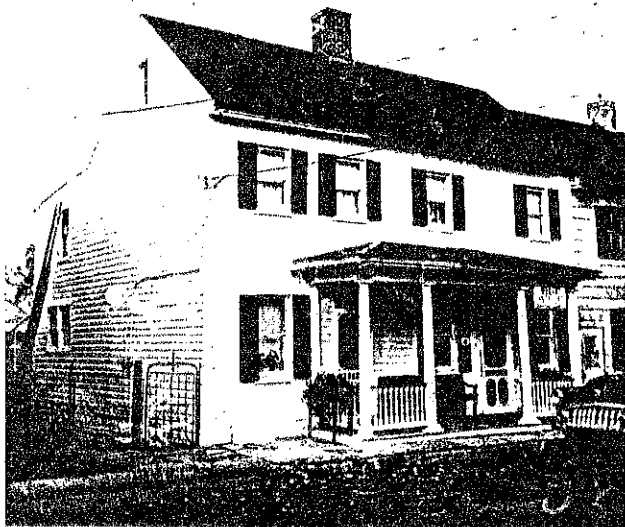
Architect or Builder - Mrs. Mary Burrall

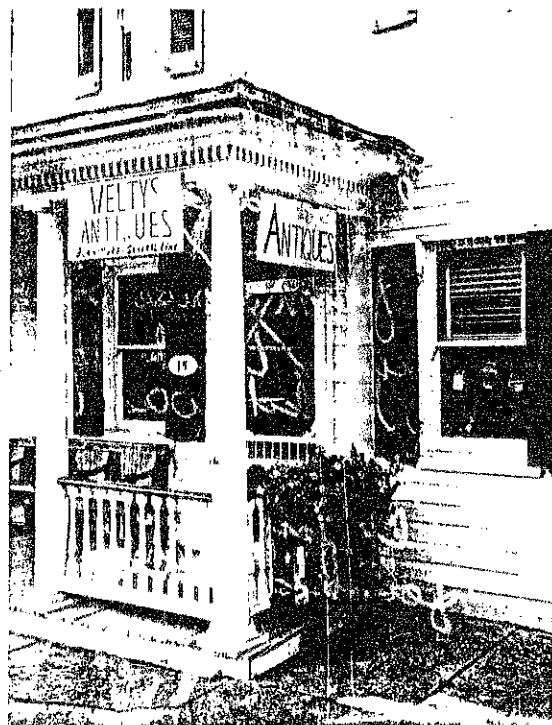
15

Owner - Mr. & Mrs. Paul C. Wolff  
One family - Commercial

Weatherboard circa 1820

Federal  
Fair Style  
Considerable Change  
Needs Repairs

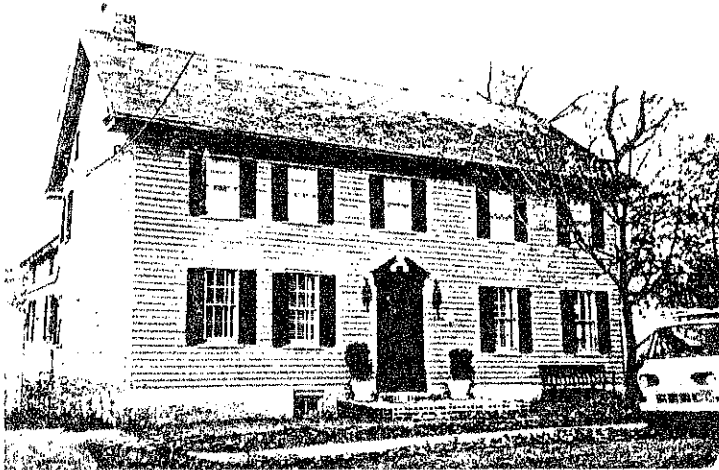
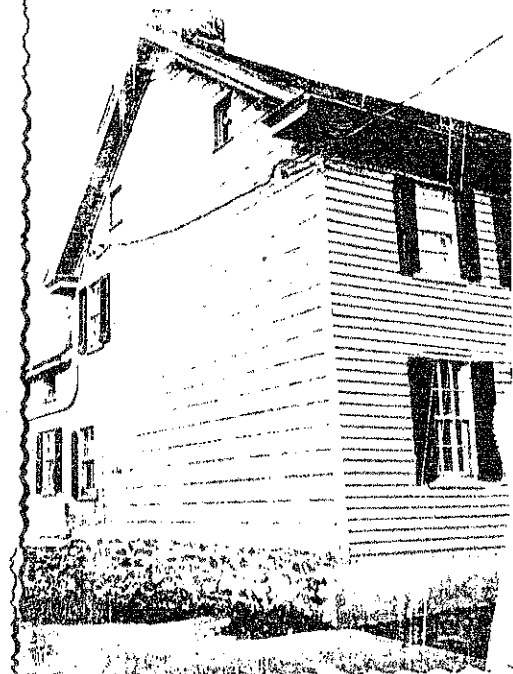
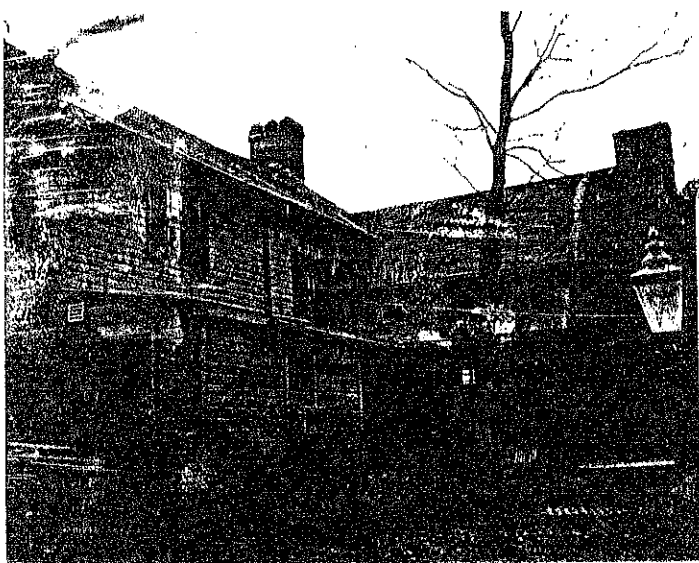
Present Owner - Mr. & Mrs. Vankub Fehr

Log & Weatherboard

circa 1770

Colonial

Excellent style

Moderate amt. of change

Good condition

This house was the farm house  
on the Plummer tract before  
New Market was laid out.

1. End chimney plan used (Great improvement to houses in early times)
2. Wood house, (2nd in use was brick) (Wood popular in New England wood usually allowed to weather, sometimes dark green was used - this building is a dull green. Wooden houses had overlapping or dropped siding)

3. Doorway is central and featured.  
Pilasters aren't large, but are used just the same.
4. Pediment over door (broken pediment used in that time).
5. Window type is example of early nineteenth century window in Providence, R.I. look. Windows were usually simple.

6. Sliding windows with little square panes of glass - 18th cen.
7. Often the house was enlarged by the sweep of the roof carrying down in the rear, and creating an ell or continuous addition.

8. Floors (stones of house) are low.
9. Five windows across front on axis with openings below - one central door flanked by 2 windows on each side.
10. Next to the door, the most important feature of the house was the corner horizontal wooden brackets running length of house, front & back. ~~Very deep~~ <sup>deep</sup> overhang on this building.

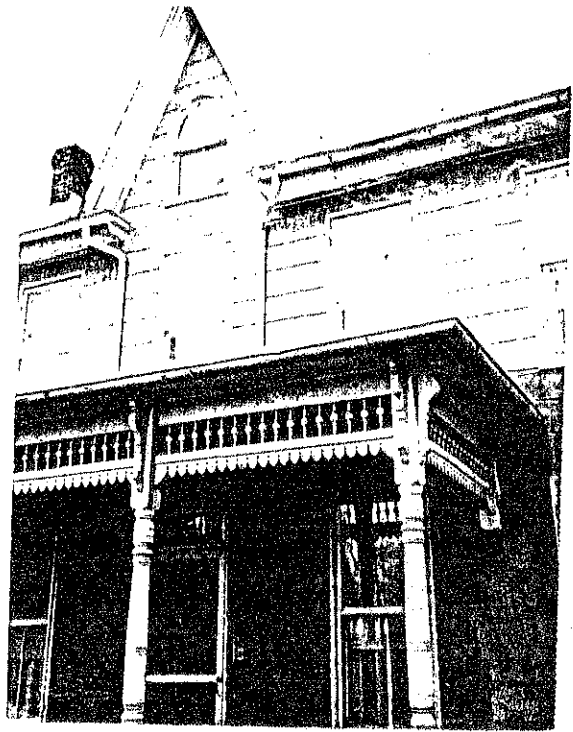
23

Mr. & Mrs. Clarence Bennett  
Original Use - Dwelling  
Present - 2 family

Weatherboard  
Circa 1880

Victorian 1835-1900  
Fair Style  
No or little change  
Good condition

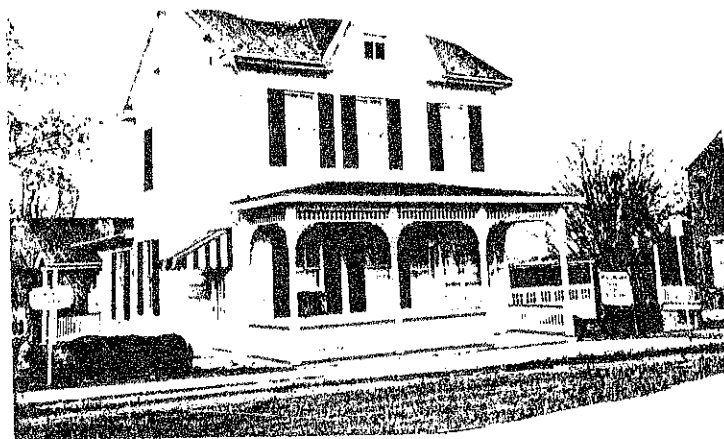
Present Owner - Mr. & Mrs. Emory Still

Material - Weatherboard

Year Built - Circa 1880

Victorian

Good style

Moderate Amount of change

Excellent condition

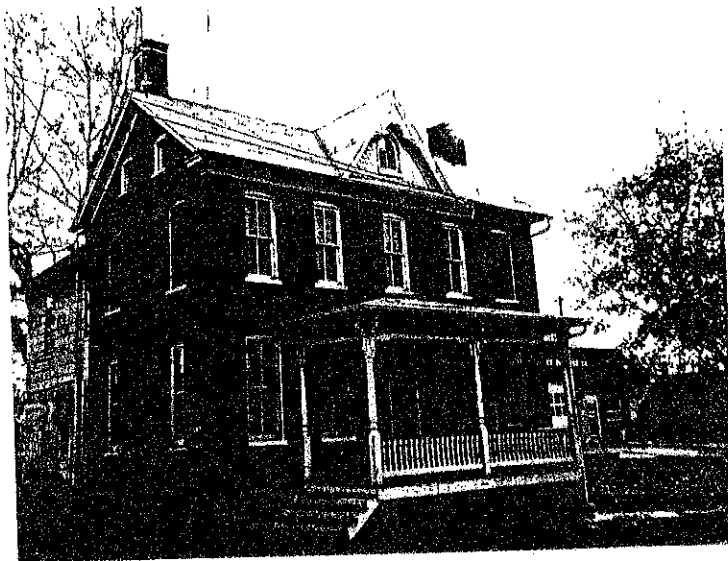
Present owner - Mr. & Mrs. Ollie Budge

Material - Brick

Year Built - circa 1890

Victorian

Good style

No or little change

Good condition

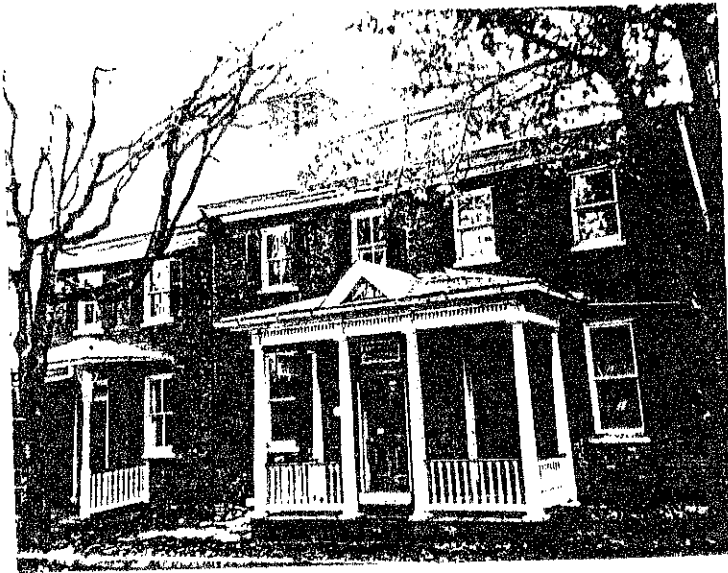
Present owner - Mr. & Mrs. Charles Wood

Material - Brick

Year Built - Circa 1820

Federal

Poor Style

No or little change

Major repairs needed

1. May be called a "double house," which became popular after 1815.

If porch were exaggeration of cornice with triangular pediment, this could be said, as 2 doors under one cornice became popular with double house.

2. Chimney at each end

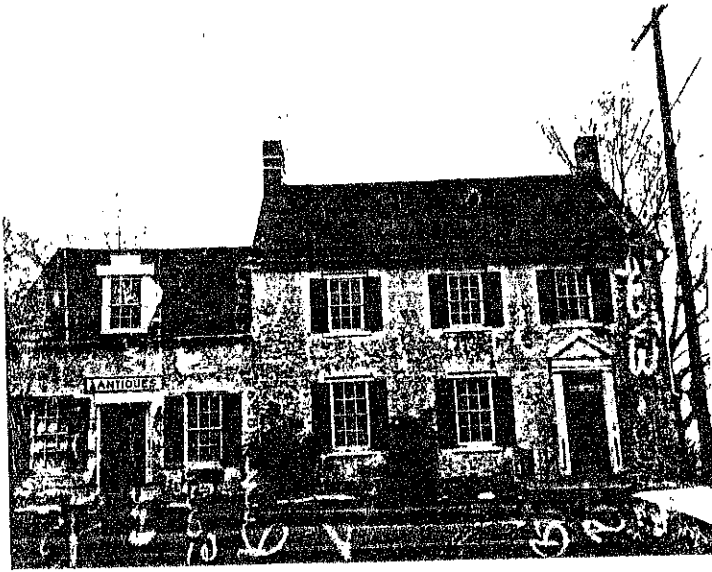
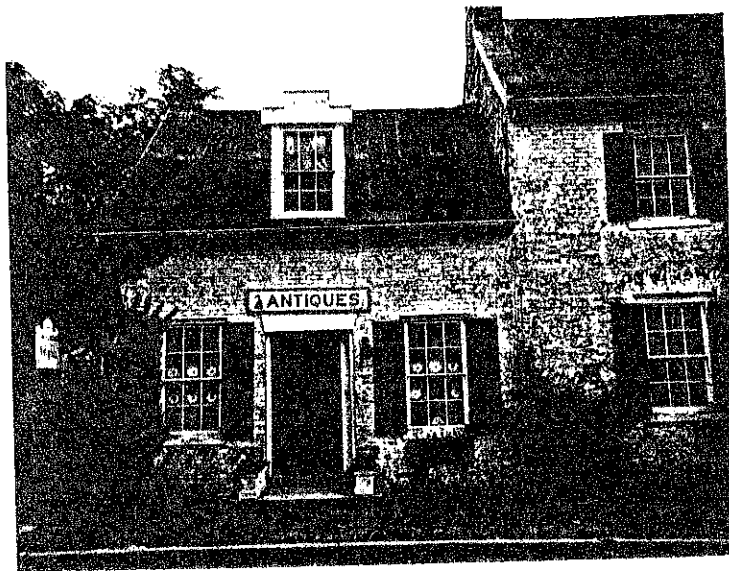
Present Owner -

Mrs. Majie Perham

Material - Brick

Year Built - circa 1800

Federal

Exceptional Style

Moderate Amount of Change

Needs Repairs

Run as an early inn.  
Early Blacksmith shop  
on the premises torn  
down 1945.

1. Triangular pediment

2. Two interior end chimneys

3. Brick

4. Wrought iron railings on porch

5. Work on fanlight over door. (appearance of columns at door)

6. Type of window similar to window type (John Holden Green buildings) in Providence, R.I. look.

7. Area over antique shop door similar to window type designs - block

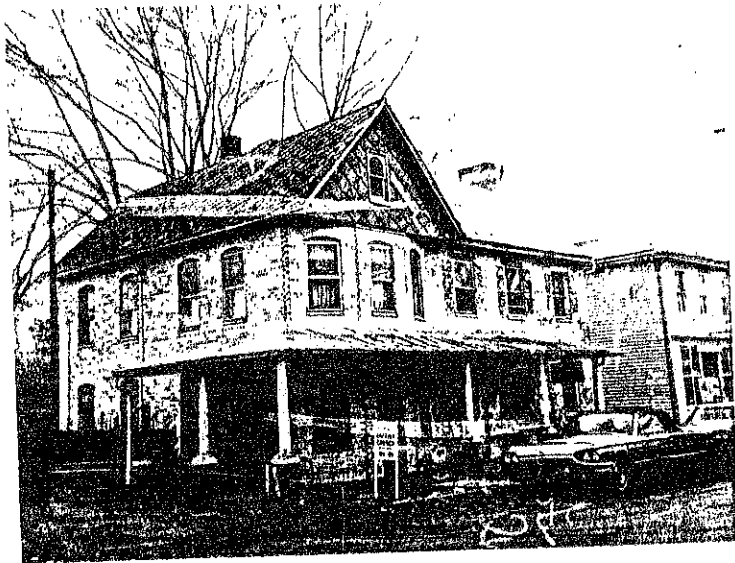
P.

Present Owner - Mr. & Mrs. Franklin Shaw

Material - Brick

Year Built - West Wing circa 1830

East Wing early Twentieth Century

Federal

Victorian

Fair Style

Moderate Amount of Change

Needs Repairs

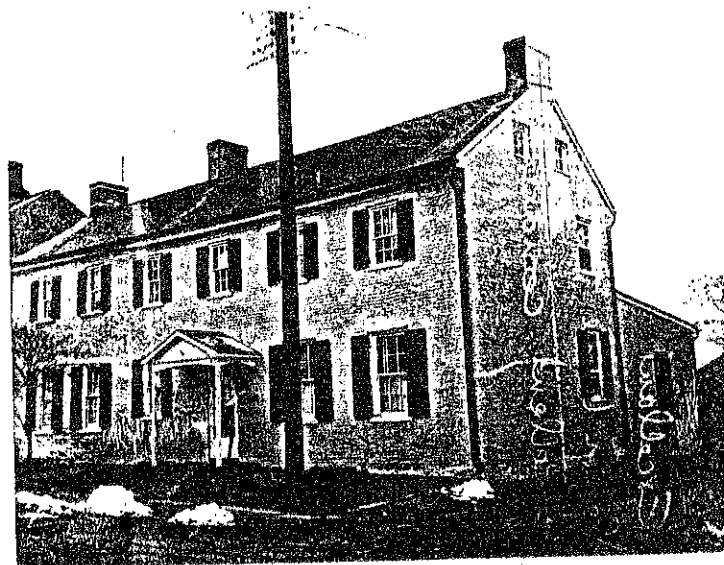
Present Owner - Mr. & Mrs. Benjamin D. Palmer

Material - Brick

Year Built - circa 1800

Post Colonial 1775-1800

Excellent Style

No or little change

Excellent Condition

1. Designs over windows are examples in Providence, R.I. book.
2. Small roof over porch.
3. Three chimneys - one at each end, one centrally located - typical of Federal period.
4. Brick, although red was popular in Post-Colonial period, creamy yellow was used in Federal period. - this house is yellow brick.

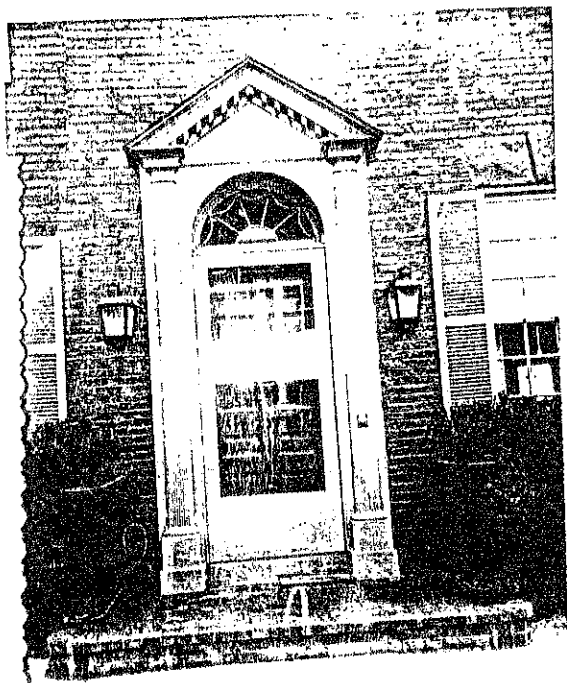
Mr. Stoll N. Kemp

Material - Brick

Year Built - circa 1800

Federal 1800-1830

Exceptional style

Moderate Amount

Excellent condition

1. Made of red brick

2. Two interior chimneys, end.

3. Curves, festoons, interlaces on exterior cornices.

4. Lanlight door with columns.

5. Stone steps (brick) with wrought iron railings.

6. Flat headed arches over windows (End blocks with raised block in center.)

7. Some windows are smaller.

8. Type of shutters are typical.
